Investigation Study on the Massive Flooding in the Municipalities of San Teodoro, Baco, Victoria, Naujan and City of Calapan during the Typhoon NONA on 15 December 2015

A CONSOLIDATED REPORT

TASK FORCE IWAS-BAHA 18 April 2016

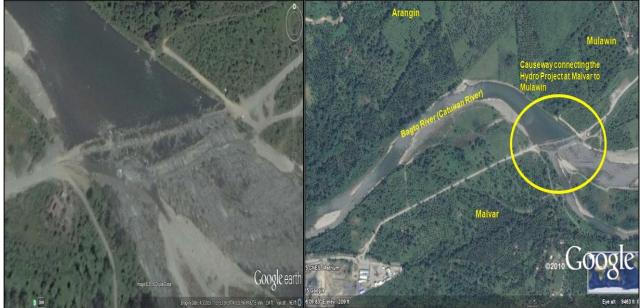
Man-made structures across Catuiran River and Mayabig River, to some extent, aggravated the effects of TyphoonNona^{"8}. The causeway^{"9}affected the riverflow; however, its effect is significant only at the initial stage of the rising floodwater, but effect becomes less significant as the floodwater rises.^{"10}

Figure 2. Causeway 2015 Source:EfrenGarcillano

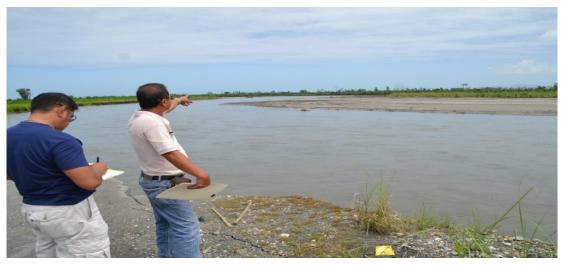
Figure 3. Riverbed and bank erosion resulting to channel widening along Panggalaan River, Brgy.Tigkan, Naujan, Or. Mindoro.

It is worthy to note that "there had been observed significant effects in the river system by the long-term "riverine"²⁴ quarrying, which includes but not limited to riverbed and bank erosion/bank collapse (*Figure 2 and Figure 3* resulting to channel widening specifically in Alag River (Brgy. Mangangan II) and Panggalaan River (*Brgy.Tigkan*); significant bed lowering resulting to channel enlargement (*Alag River, Mangangan II, Baco*). The irregular occurrence of diggings/hole left behind in the river bed (*Baco-Bucayao River, San Luis*) that increase in slope thereby increase the capacity of the river to scour its bed that aggravated bank collapse (*Figure 4*)."²⁵

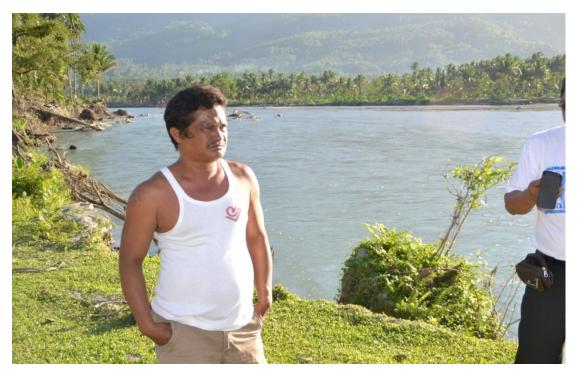
Figure 4. River bank that collapsed resulting from river channel widening along Alag River, Mangangan II, Baco

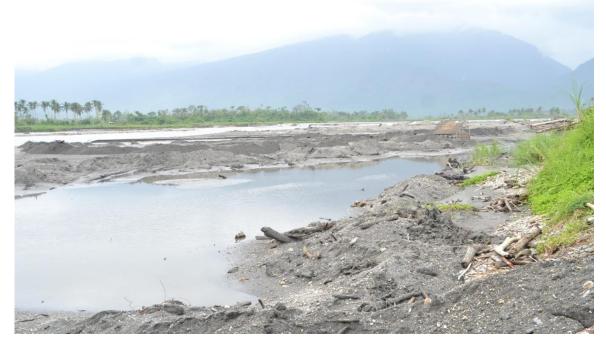
Figure 5.The irregular occurrence of diggings/hole left behind in the river bed (Baco-Bucayao River, San Luis) increase the capacity of the river to scour its bed that aggravated bank collapse.

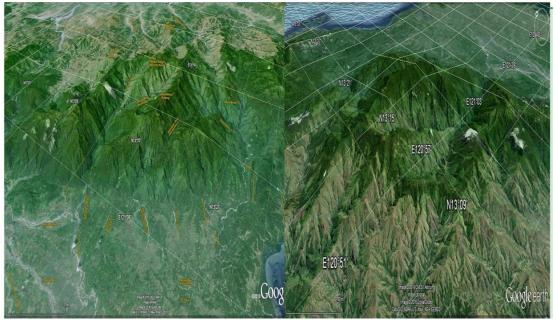
Figure 6.The Mt.Halcon watershed as viewed from the northeast looking towards the southwest. (Bottom) The Mount Halcon watershed as viewed from the southwest looking towards the northeast(*Garcellano, 2016*). Source: Figure 8 in Team B Report

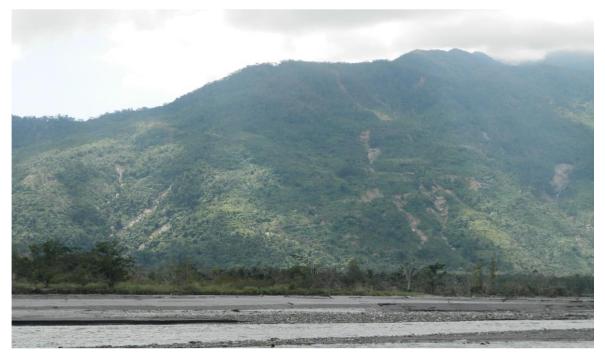
Figure 7.A portion of the Catuiran River watershed sadly dubbed by the team as "The Crying Mountain" owing to the numerous landslides resembling cascading teardrops. *Source: Figure 9 in Team B Report*

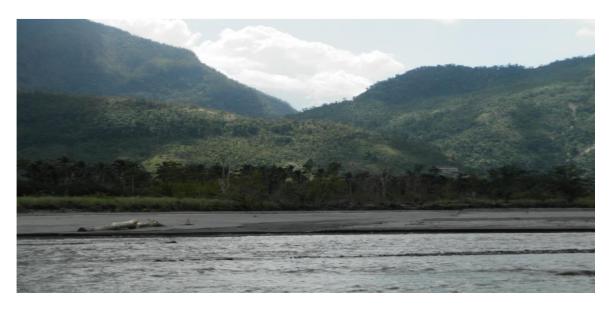
Figure 8. Thinly vegetated watersheds, of Catuiran River, that needs immediate rehabilitation. Issues such as these can be addressed by the honest implementation of the Integrated Watershed Management Plan.

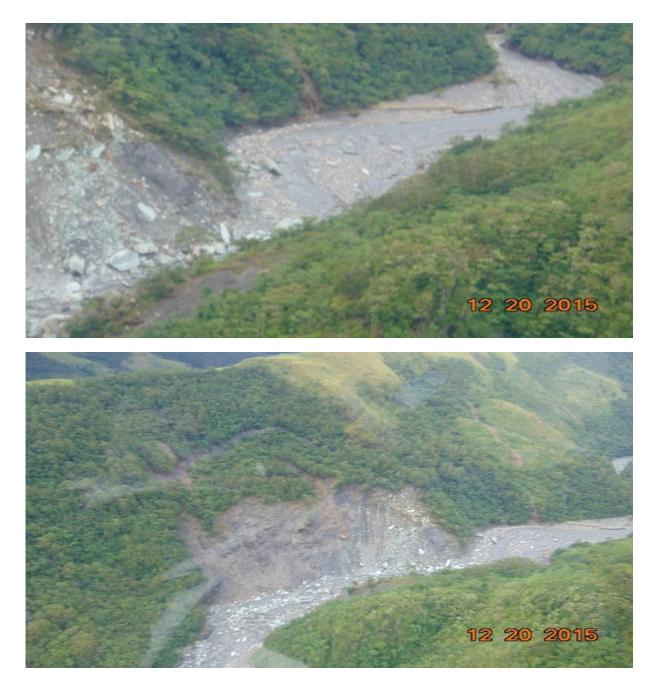
Figure 9: Aerial Survey after Typhoon Nona. Multiple landslides occurred at the upper section of the river *Source: SCIC*
