Ref. No. : SCIC-CON-MON-15-27
Date : May 11, 2015

We refer to your letter dated May 6, 2015 regarding the isolated rockfall that occurred within the Project Site on May 4, 2015 which claimed the lives of 2, and injured 5 of our fellow workers and brothers in SCIC. It is truly unfortunate and tragic, and we join the local community in grieving such loss.

OVERVIEW OF THE WEIR, INLET PORTAL AND DESANDER

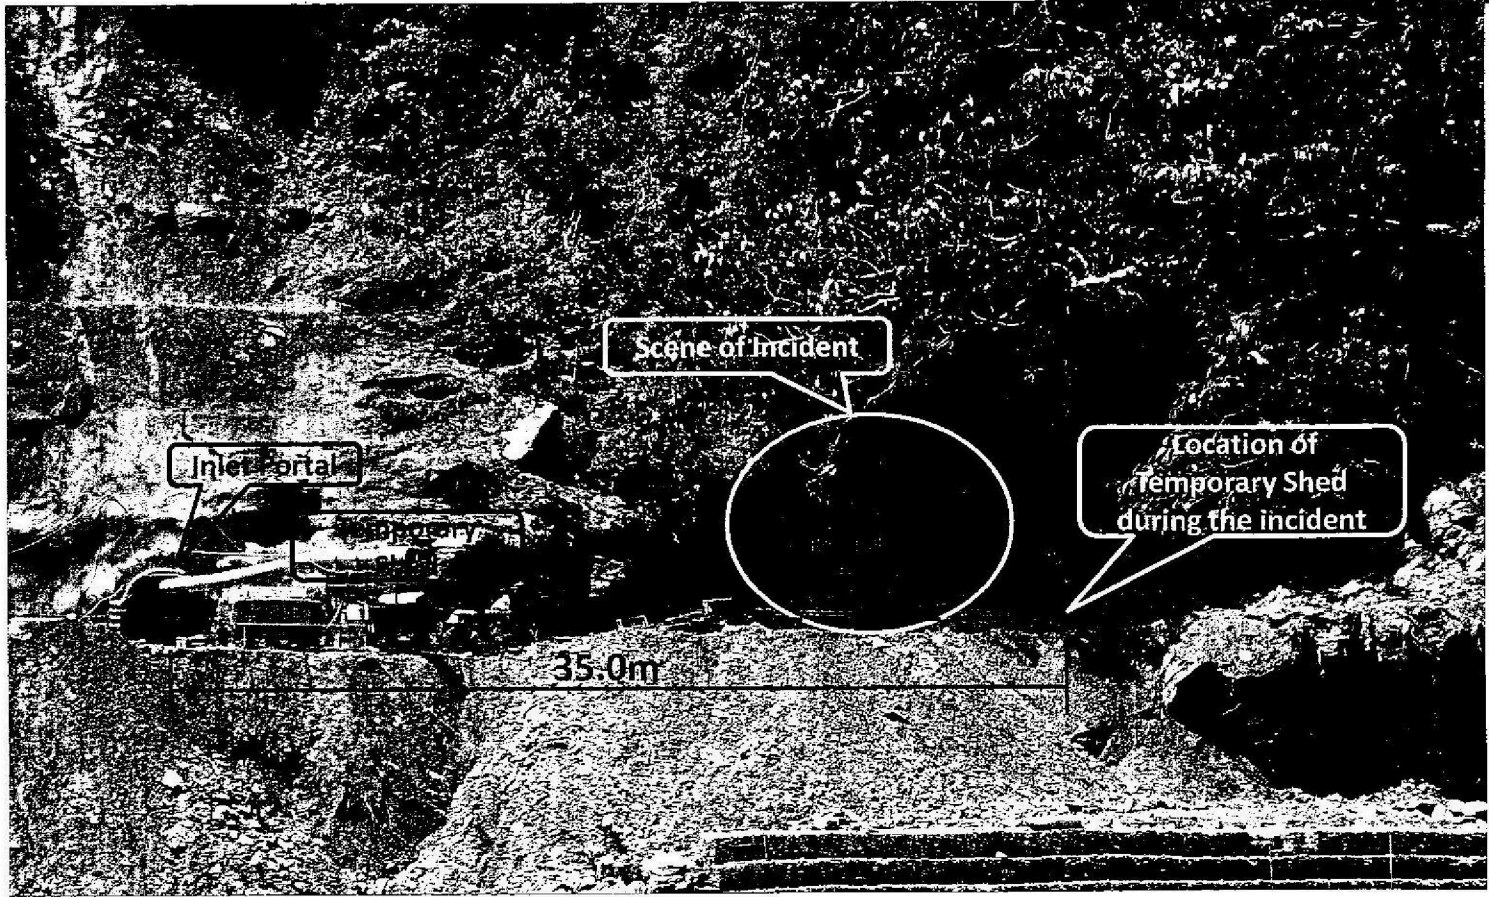
PHOTOS TAKEN BEFORE THE INCIDENT

- On May 4, 2015 at around 1:30 AM, the 7 workers were on their break-time and decided to rest at the temporary rest area 20m (actually 35m) away from the opening of the tunnel and about 200 m from the work site where the workers were assigned;
- The mountain side above the area where the workers were resting was covered with thick vegetation, thus, giving no sign that rockfall in the area was imminent;
- Suddenly, without warning, hard massive rock fragments estimated to be 20 cu.m. fell on the workers which injured 5 and caused the death of 2, as above mentioned;
- The rocks fell from a height of only 3m, more or less;
- What occurred was an isolated rockfall and NOT a landslide.
